Investigations outcome 006

Incident Date: 21 July 2023

Party in the CoR: Operator, Loader and Loading Manager

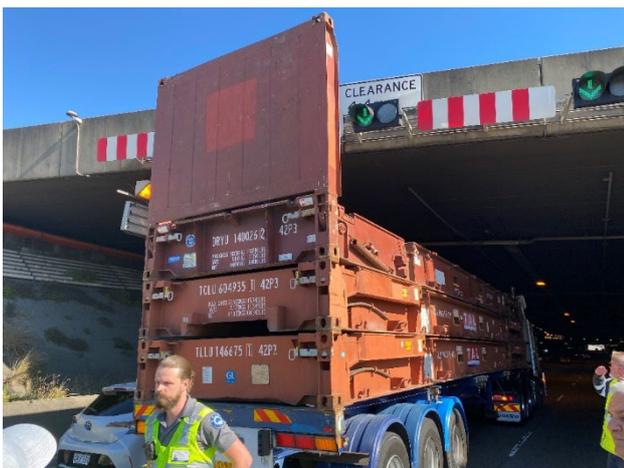
The vehicle of interest was a New South Wales registered heavy vehicle with a 3-axle truck towing a 4-axle semitrailer loaded with one freight container with an overall height measurement of 4.46m

The investigation revealed a container flat pack loaded on the trailer of the heavy vehicle was not secured with two safety pins, which prevents the flat pack's end safety barriers from becoming dislodged and opening (into a vertical position). It was shown that only one pin was used to secure the flat pack, with the other pin either falling out during transportation or never being secured in the lock position before departure.

After consultation with the company Director, COR and safety compliance manager, the Operator provided the investigator with an updated Policy and Procedure that included the use of height sticks, drivers being updated and trained in the use of height stick devices and general improvements with compliance to dimension, mass, and load requirements. The Operator's updated process Safety Management System effectively identified risk mitigation as per the Master Code. This

also included a driver declaration, which includes checking the securing of loads by safety devices, including locking pins and ratchets, which is signed prior to transit.
