Section 6

Structure and Body Condition

To ensure the vehicle body is free of protrusions, structurally sound and free from any defects or additional fittings that are likely to increase the risk of bodily injury to any occupant and other road users.

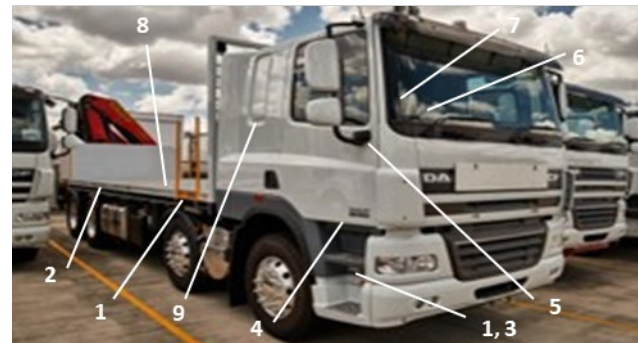
Typical primary structure components

This category includes any structure or component which, if it collapsed, would make the vehicle uncontrollable or would considerably reduce occupant safety in a crash. Examples of components in this category are illustrated below.

1. Main structural members such as sub-frames and chassis rails

Suspension mountings and parts

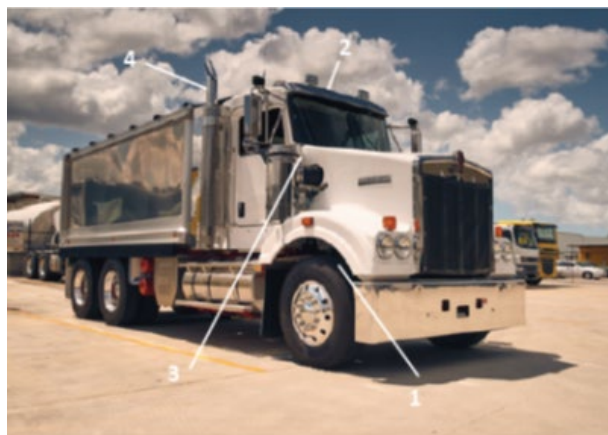
Typical secondary structure components

because of its sharp edges or because exhaust fumes can get into the vehicle. In such cases, extensive rust must therefore be rejected. The illustration below shows examples covered by this category.

1. Mudguards or fenders

Roof
