Vehicle system non-conformities

National Roadworthiness Baseline Survey Overview

The heavy vehicle health check

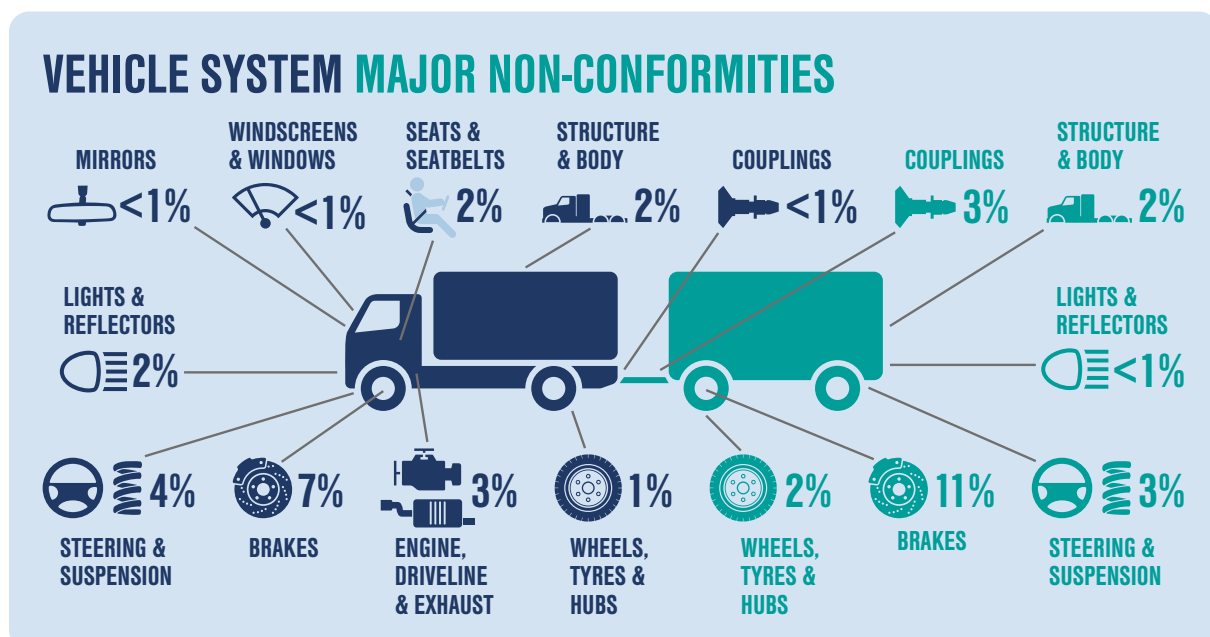
Figure 1: Vehicle system major non-conformities

For freight hauling units, the most common major system non-conformity identified was brakes (7%), followed by steering and suspension (4%) and engine, driveline and exhaust (3%)(see Figure 1).

For trailers, brake major non-conformities were the most common (11%), followed by steering and suspension (3%) and couplings (3%). The majority of these non-conformities the vehicle could continue to be used for on the road, subject to conditions and restrictions of use (see Figure 1).

For bus/coach and SPV vehicles, there were very few major system non-conformities identified. The most common major non-conformity for these vehicles were brakes (1%).
